**Study of Landslide impact on Landuse in Chooralmala village in Wayanad District Kerala 2024 using Remote Sensing & GIS**

# Study of Landslide impact on Landuse in Chooralmala village in Wayanad District Kerala 2024 using Remote Sensing & GIS

**Project Location:** Punjirimattom, Mundakkai, Chooralmala, and Vellarimala villages in Meppadi Panchayat, Vythiri taluk in Wayanad, Kerala.

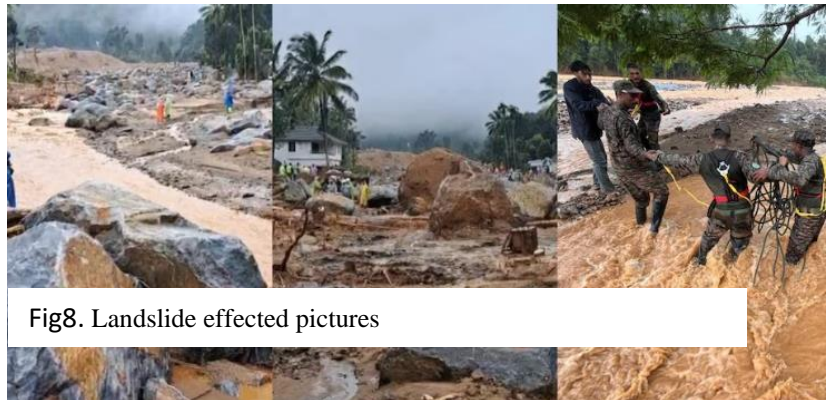
Fig8. Landslide effected pictures

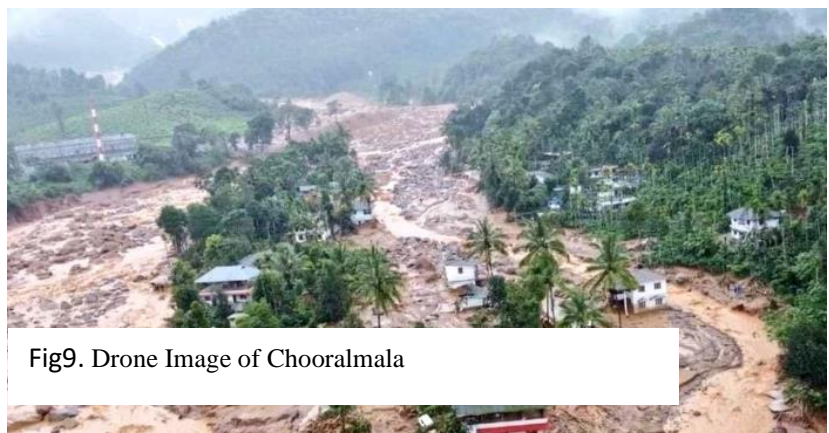
**Drone Image of Chooralmala Village**

Fig9. Drone Image of Chooralmala

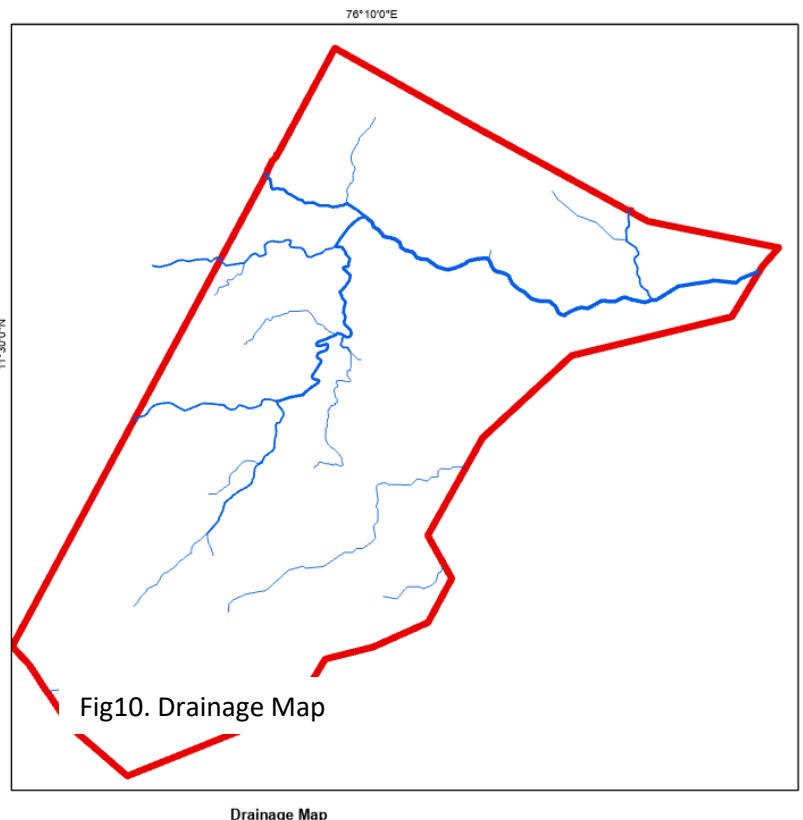
**Drainage Map**

The Study area is covered with 1- 4th order streams.
